Analyses of mortars from St. George's cathedral, Great Novgorod

E. Ianovskaia¹, A. Vozniak², A. Nosova², L. Sazonova³, N. Lebedeva³, K. Erofeeva²

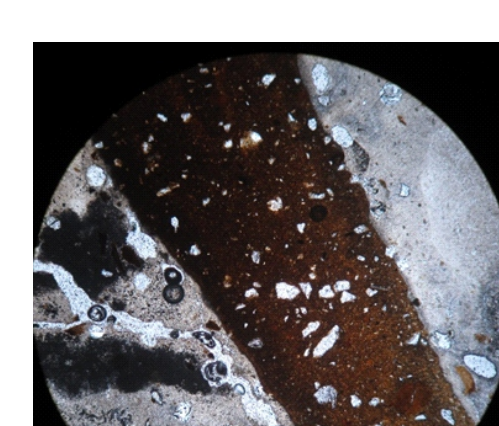
Fig.4 S-2 Large fragment of brick with quartz grains inside

Sample S-2 comes from the floor of the tomb, while sample S-4 comes from a certain 12th century foundation. The mortars are similar, with a large amount of brick fragments (L.: 0.3 to 5 cm) and a very small amount of quartz (sand, around 5%) and organic material present in both. It is worth noting that fragments of earlier mortar are present in the foundation mortar, possibly taken from some other construction site (for example from St. Nicholas Cathedral on Dvorishche, 1117).

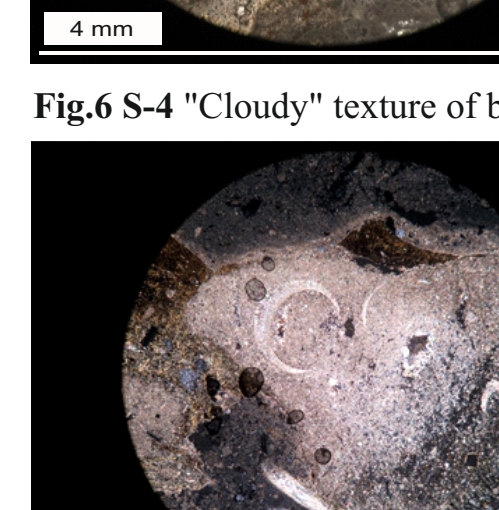
Fig.8 S-7 Large fragment of organogenic detritus limestone

Samples S-6 from the altar and S-7 from the reinforcement of the foundation can be attributed to the time of renovation in the 1820s (according to the archaeological data) [5]. The main difference is the amount of quartz in the altar mortar (45%) and the presence of unburnt limestone and non-homogenized lime (30%) in the foundation mortar, perhaps added to create some kind of supporting structure.

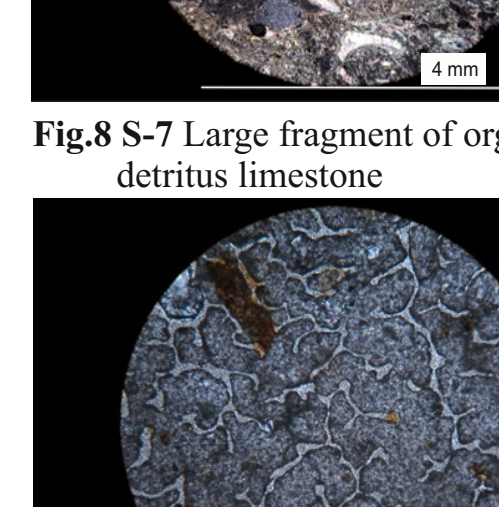
Fig.10 S-12 Main view of the sample

Samples S-12 and S-13 come from the holes left by the now missing beams in the Tower Chapel. S-12 is very friable, was prepared in an epoxy mount. Both mortars contain fragments of clay burnt for this purpose (Fig.10, 11). This addition is not found in the foundation mortars, but the same aggregate can be seen in sample S-17 from the S-W semi-pillar (Fig. 17). The S-W semi-pillar shows two masonries, both of *plinf*a (thin Byzantine bricks) with brick fragments (*tsemianka*), but they are divided by a vertical seam in the centre of the pillar. The binder on the East of the pillar is similar to that of the foundation mortars (S-2, S-4 with a more grayish color, s. fig. 15, 4, 5) and the brick fragments show the same angular shape. The mortar on the W of the pillar is similar to the mortar from the Tower Chapel (Fig. 11, 12, 17, 18). This suggests that some changes in the structure of the

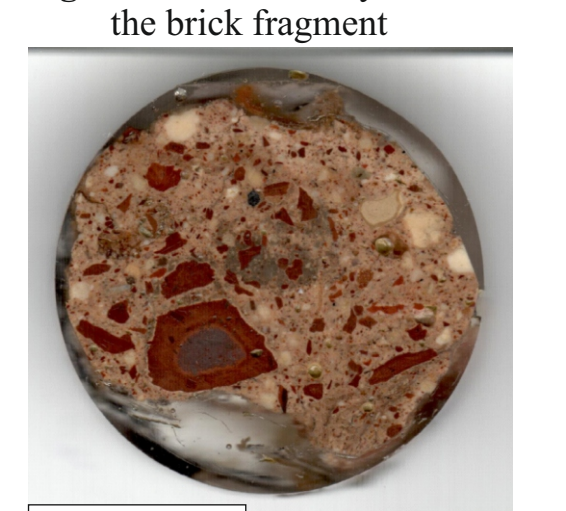
Fig.11 S-13 Dark border on some fragments of brick

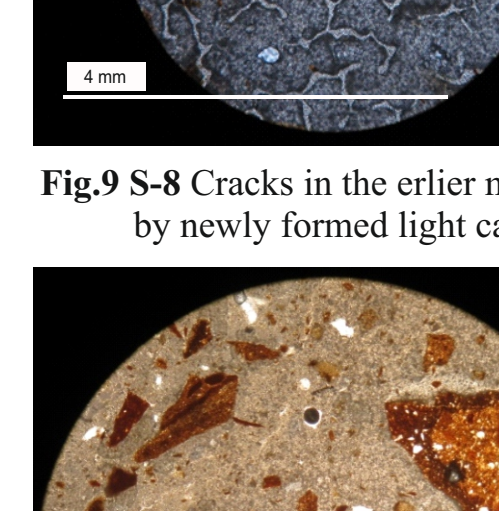
Fig.12 S-14 Accumulation of the aggregate grains

Two more samples of mortar were taken from sondage 11 outside the Cathedral. In 2021, during archaeological excavation some unknown construction to the N-E of the Cathedral, perhaps a Medieval wall, was found. Both mortars contain a small amount of *tsemianka* (S-14 2%, S-15 5-6%). They show the same kind of binder, crystalline, cloudy, and of brownish-gray color. Sample S-15 from the debris layer consists of building material, perhaps the remains of destroyed constructions. Sample S-14 from a construction foundation revealed by the archaeological excavation, shows a mortar with more sand and less brick fragments, while the mortar of the wall shows less sand and more bricks.
